NASA Technical Memorandum 83273

1981 DIRECT STRIKE LIGHTNING DATA

FELIX L. PITTS AND MITCHEL E. THOMAS

This report presents the results obtained during the 1981 direct-strike lightning tests of the NASA Langley Research Center lightning-instrumented F-106B aircraft. The tests were conducted in the vicinity of the National Severe Storms Laboratory, Norman, Oklahoma, and in the vicinity of the NASA Langley Research Center, Hampton, Virginia. The entire strike data obtained for 10 strikes in the 1981 test series are presented in this report.

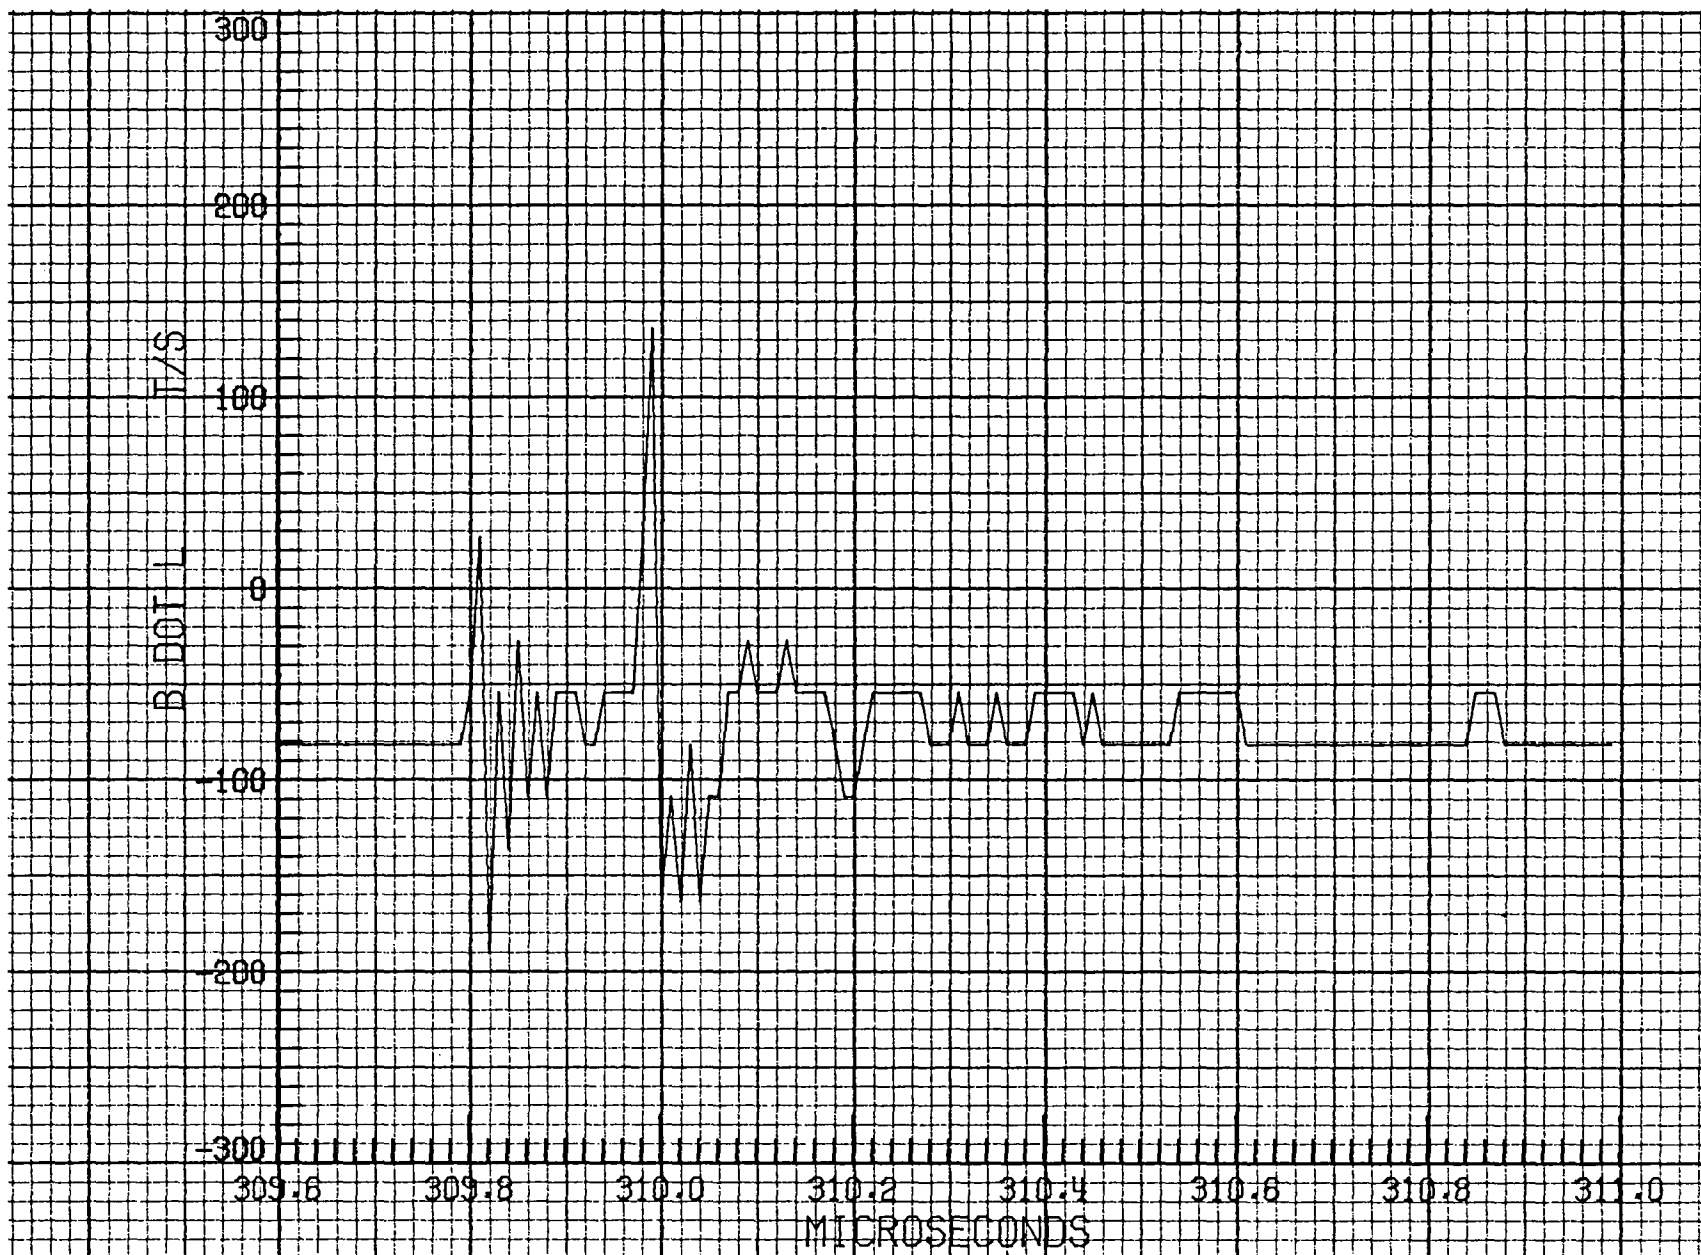
Figure 21. - B-dot sensor - flight 81-043, record 3.

The 1981 data set includes transients recorded for a number of lightning events which were not reported by the pilot as strikes to the aircraft, as in figures 16-18 and 20-27. The only measurement of pilot reported direct lightning attachment occurred during flight 81-043 (figures 19, 28, 31) when the current, I , in the pitot boom was recorded by the aforementioned Boeing Company developed data logger. Even though post-flight examinations of the aircraft reveal that all ten lightning attachments in 1981 were initially to the pitot boom, the magnitude of current in the boom was below the measurement system threshold of 6000 amperes in every case except flight 81-043.

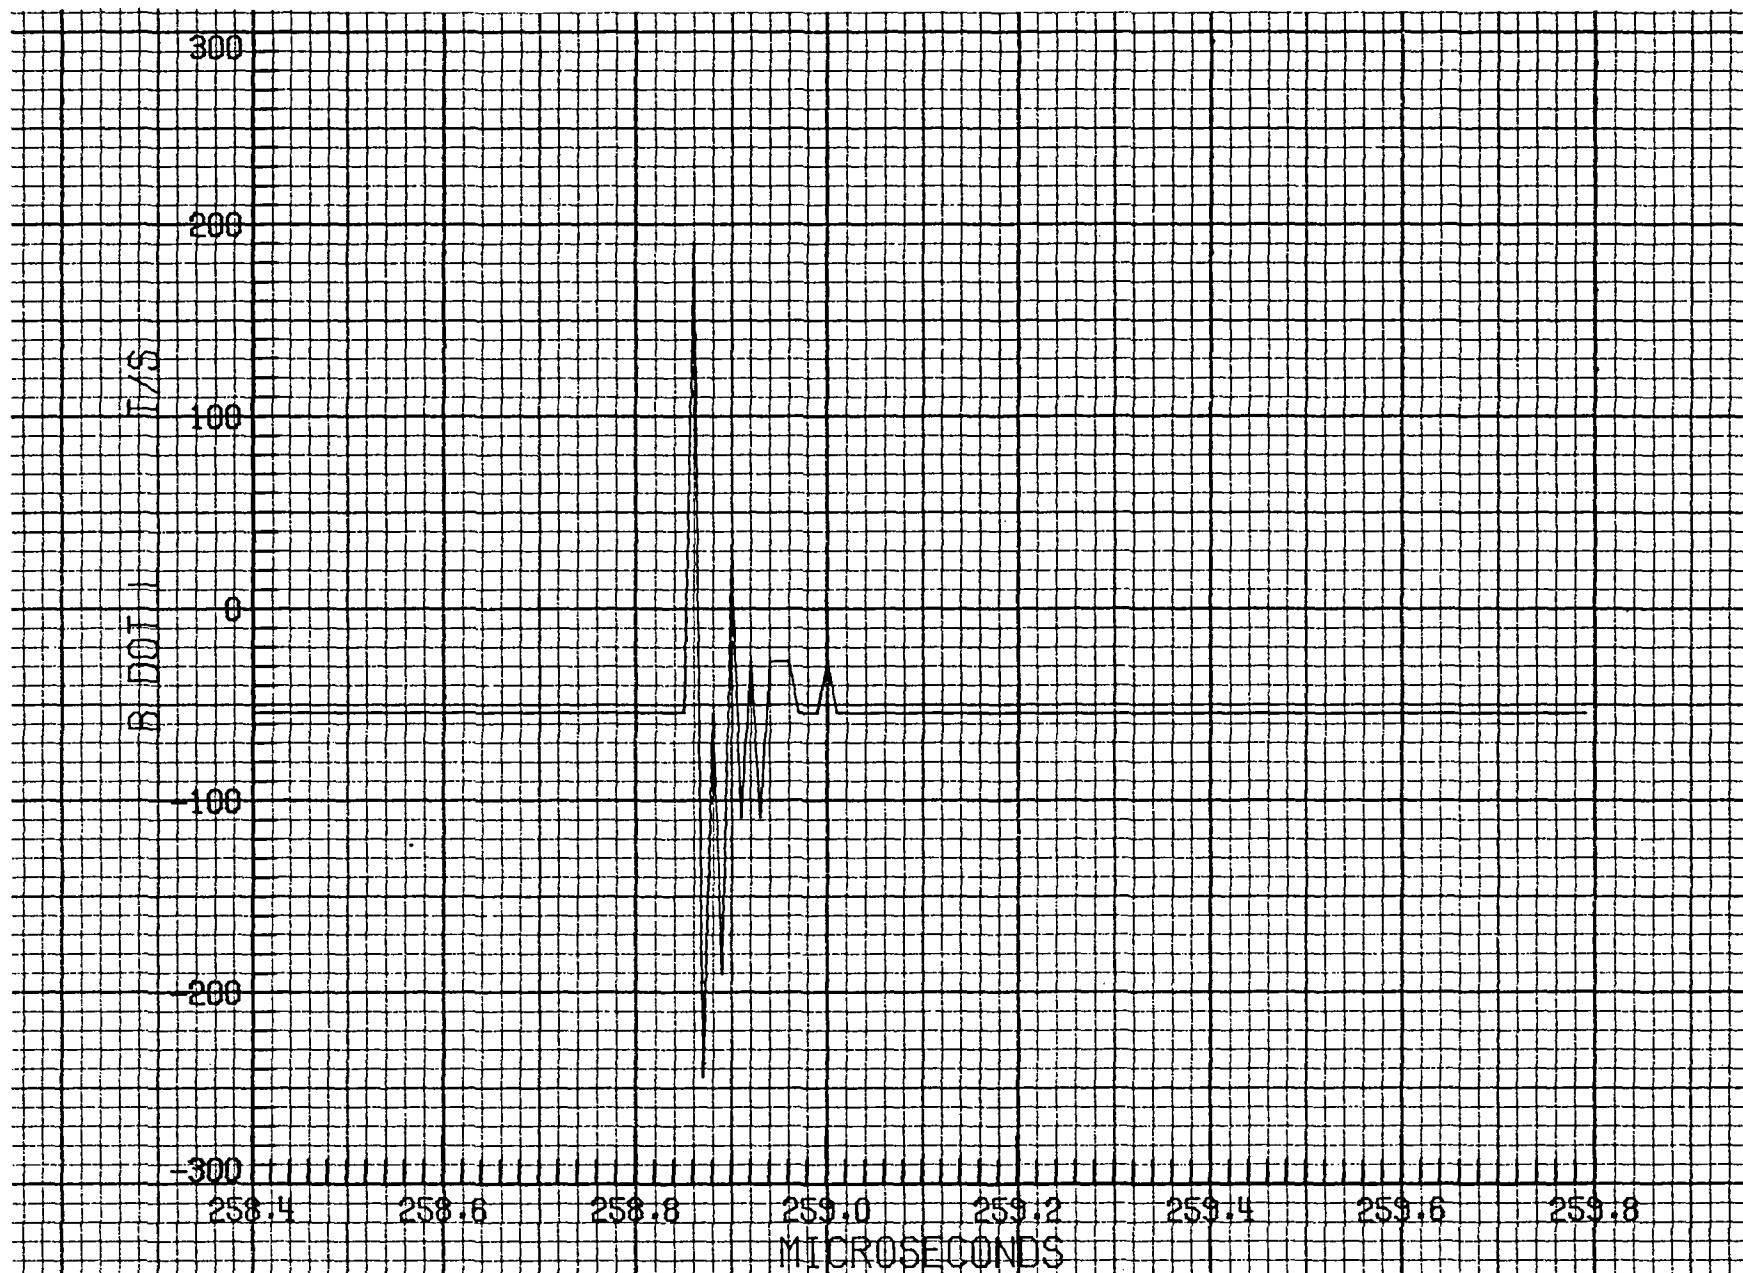
Figure 23. - B-dot sensor - flight 81-045, record 1.

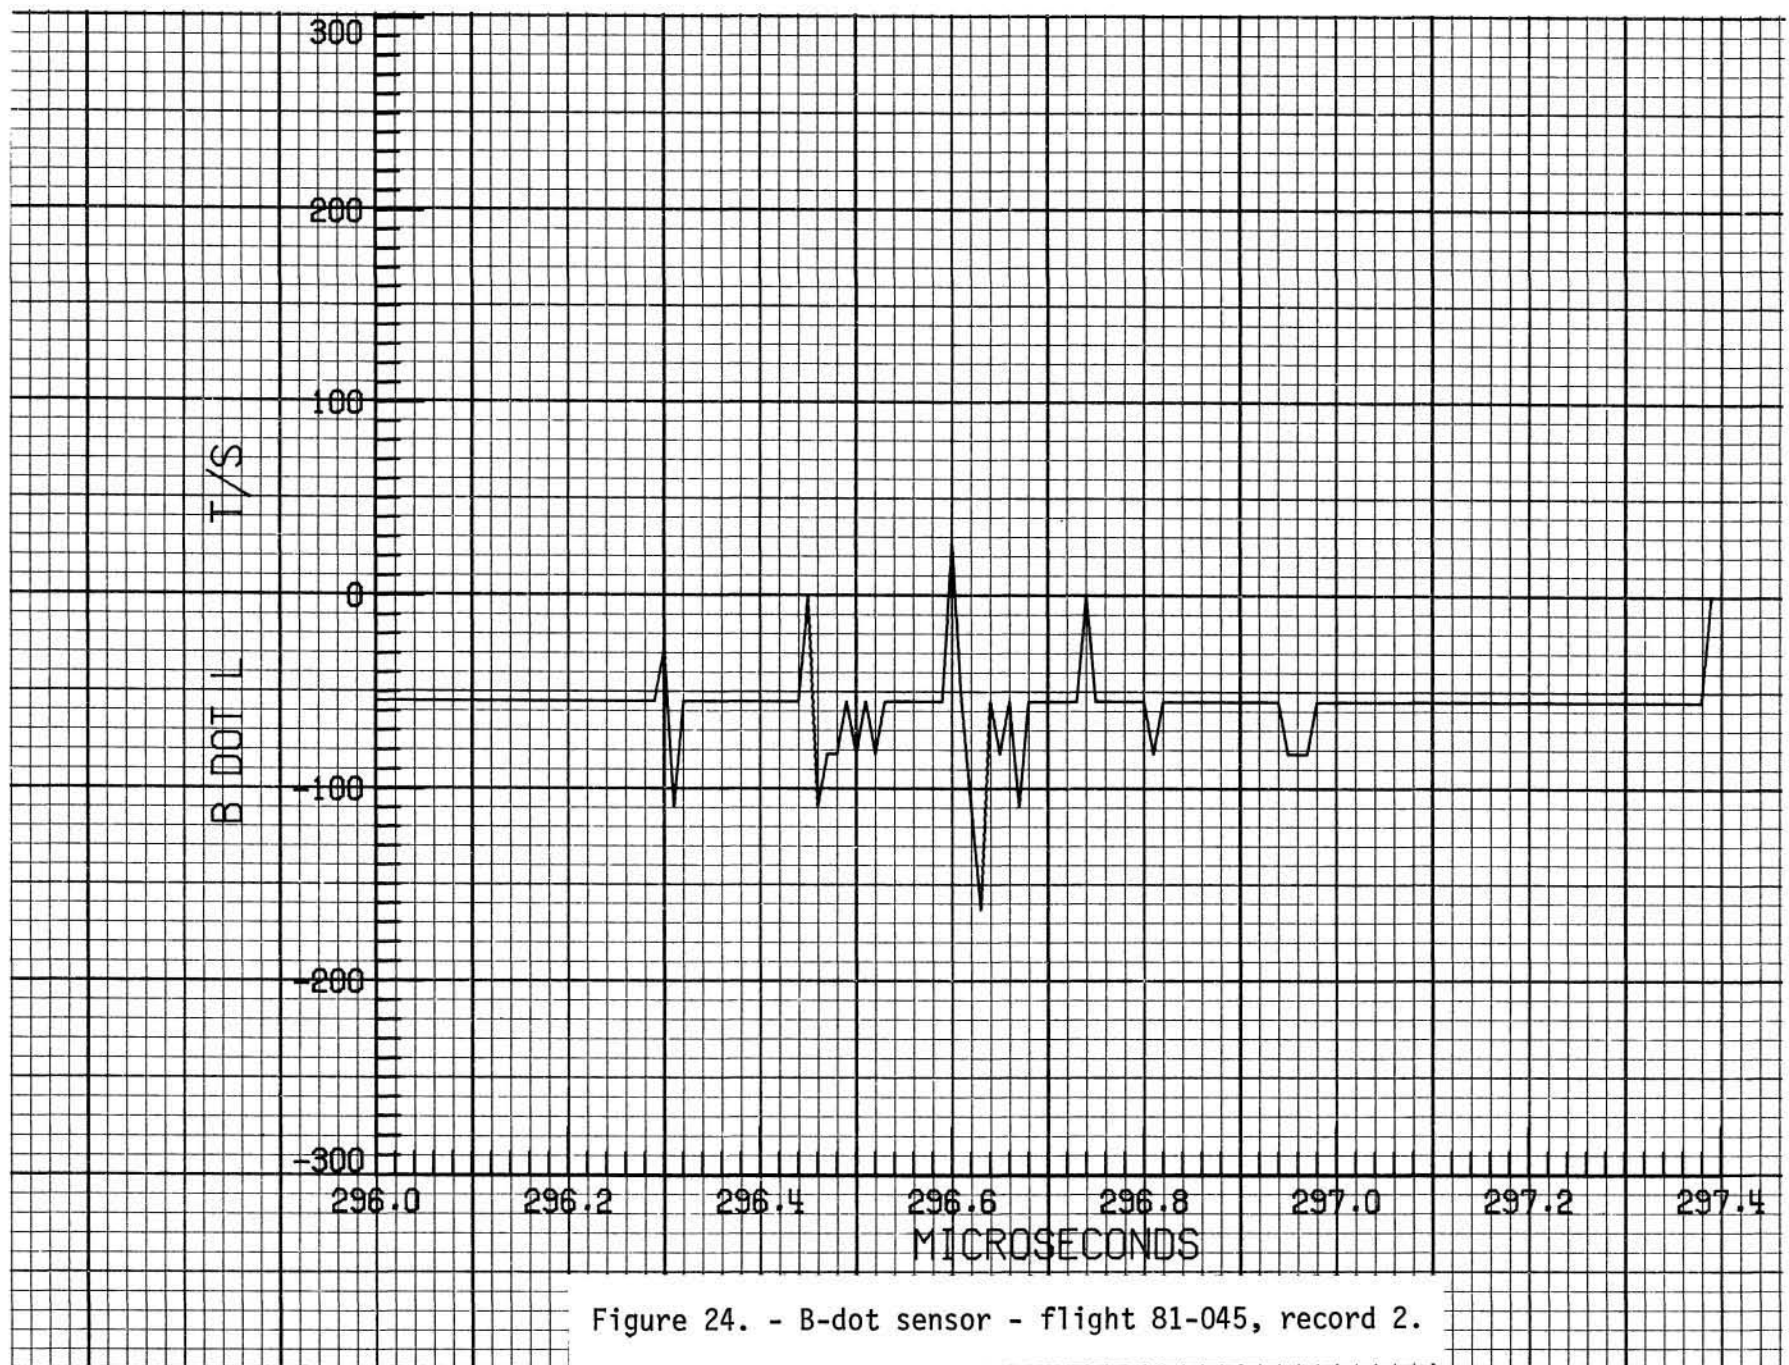
Figure 24. - B-dot sensor - flight 81-045, record 2.

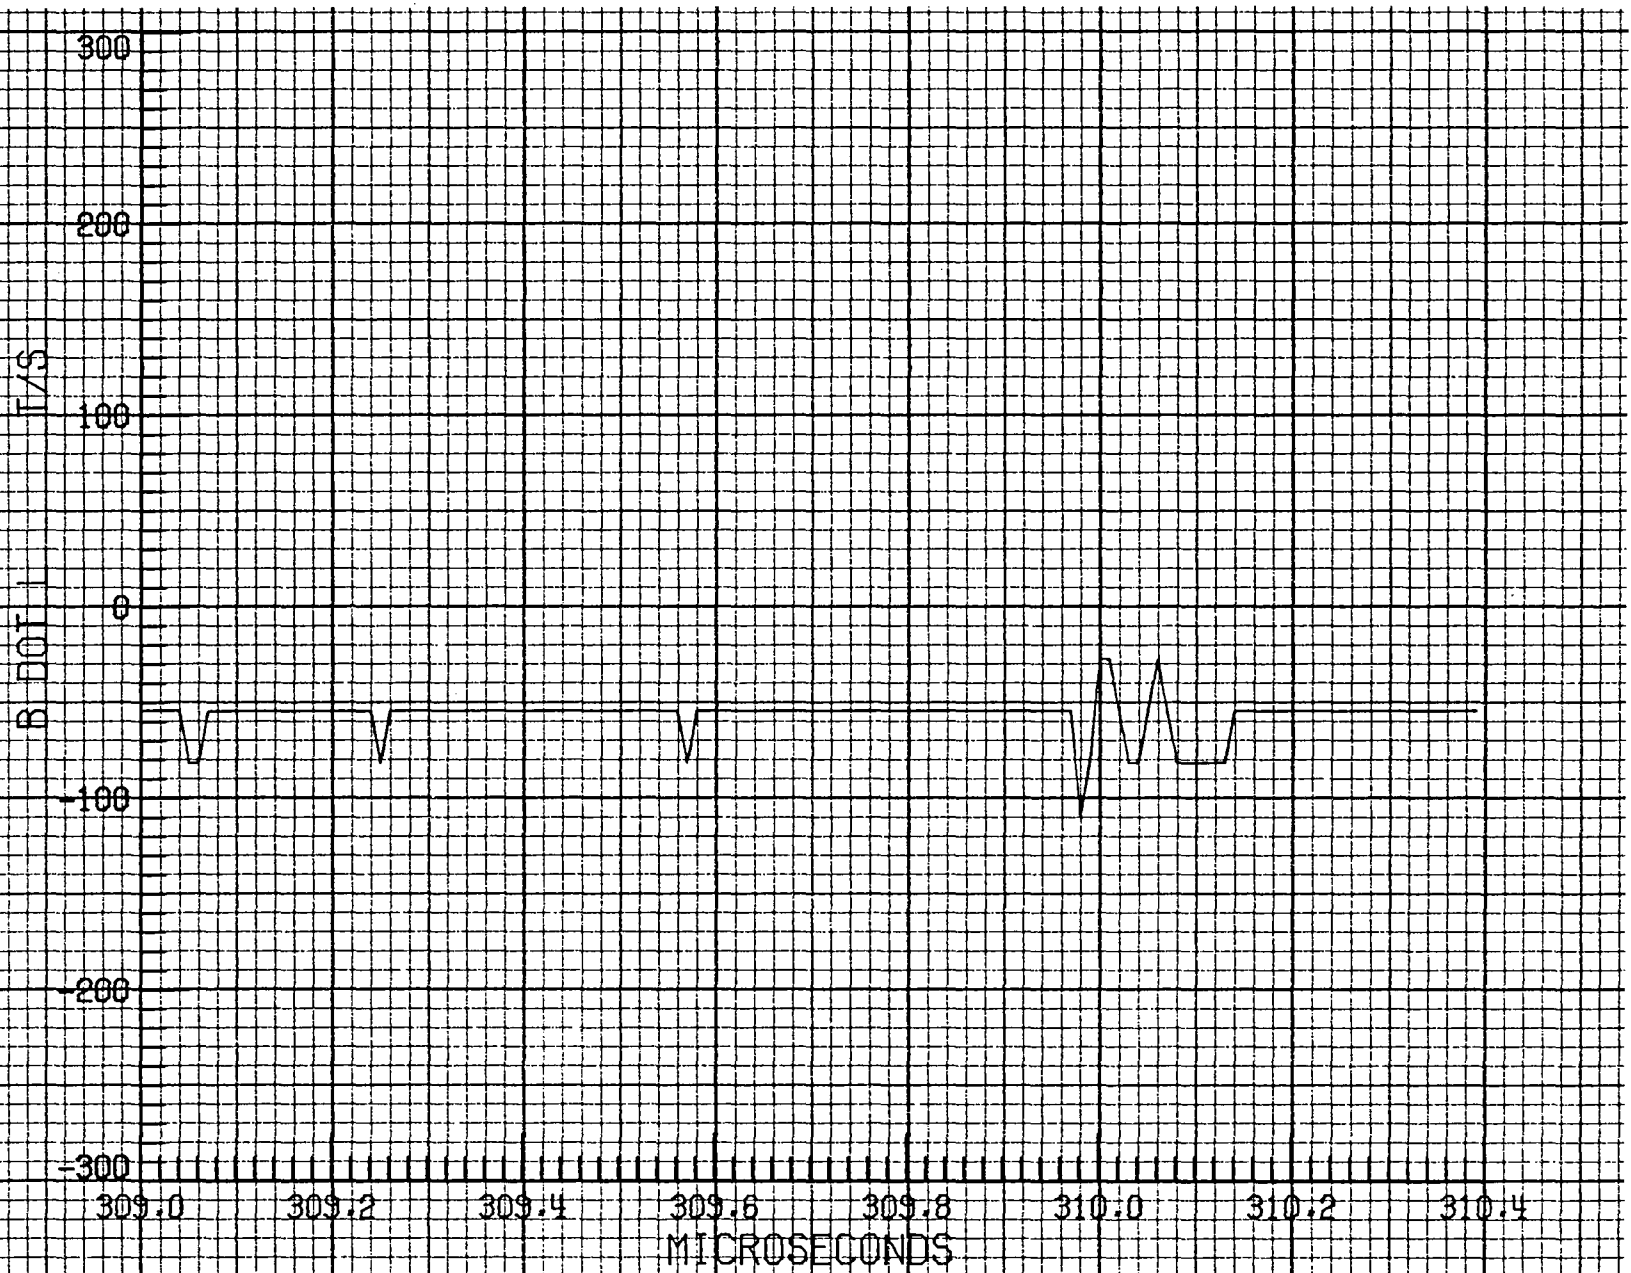
Figure 27. - B-dot sensor - flight 81-045, record 5.

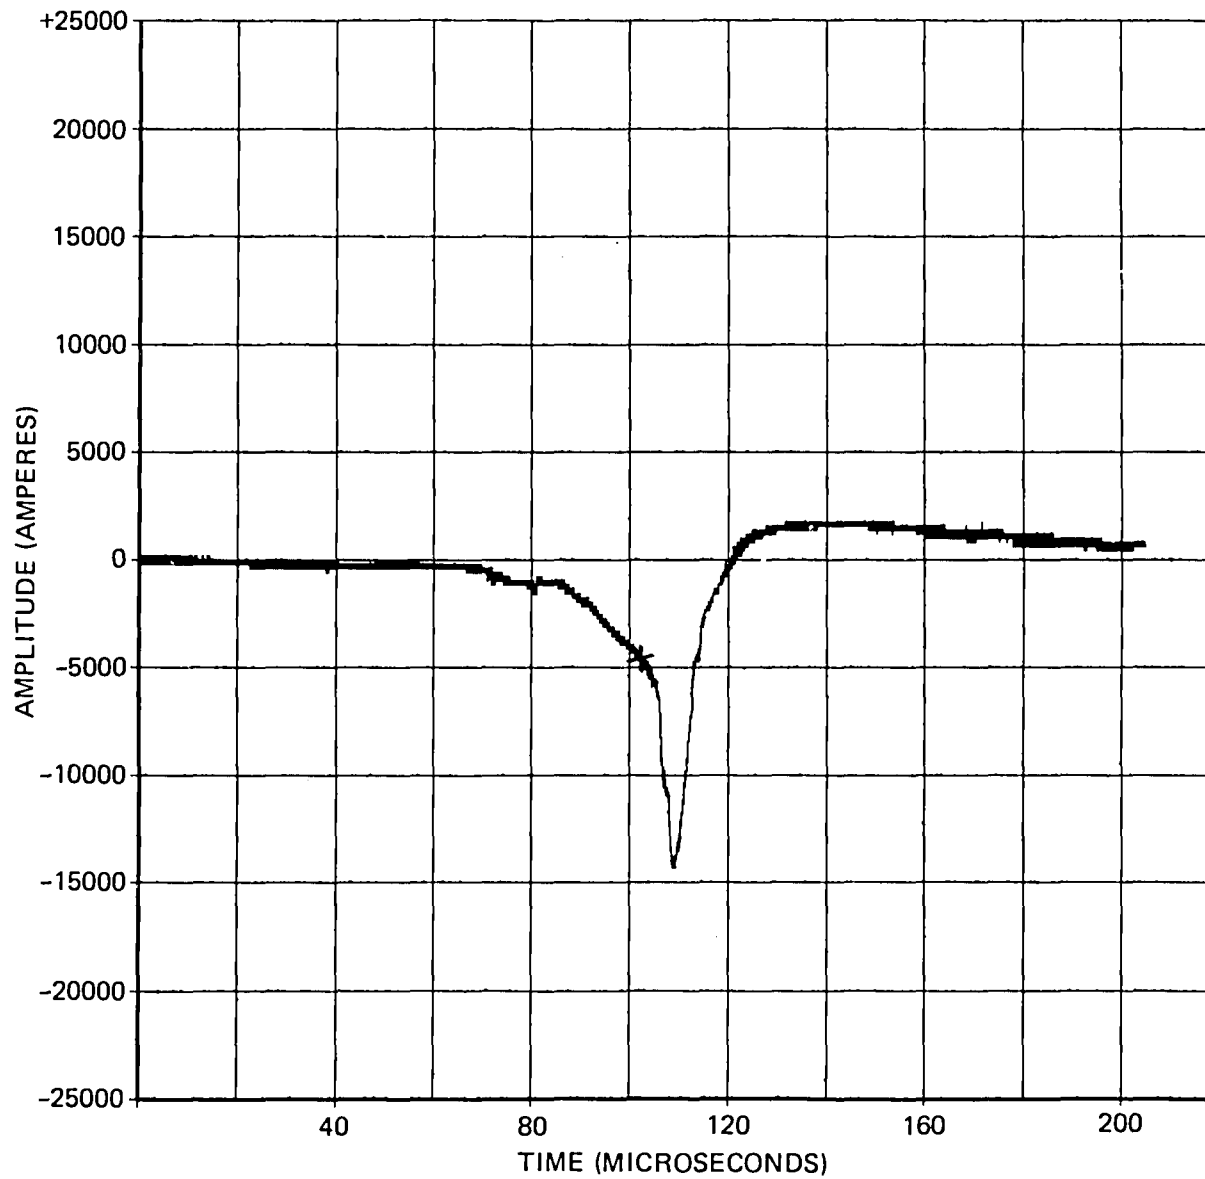
X - INDICATES TRIGGER POINT

Figure 28. - Current sensor - flight 81-043.

Figures 1 through 28 are the data waveforms obtained in the 1981 flight tests. The single current waveform shown in figure 28 was obtained for a pitot boom strike recorded by the Boeing Company developed data logger described in reference 6. The sign conventions established for the measurements shown in figure 29 indicate positive quantities in the direction of the arrows; the relation between the sign conventions of the variables D , B , and I and their derivatives are shown in the measurement polarity time history also in figure 29. There were two transient recorders; these were connected to the B -dot sensor at (6) and the D -dot sensor at (2). All of the B -dot and D -dot data reported in this paper are from these two sensors; the I data are from a sensor located at (1). The location of the lightning attachment points and lightning paths for flights 81-042 and 81-043 are shown in figures 30, 31, and 32. Figure 33 is a composite showing the temporal relationship between B -dot (figure 19), and I (figure 28) for the boom strike of flight 81-043 for sensors located at (6), (3), and (1) on figure 29. (E_z is the vertical electric field obtained by the field mill system which is described in reference 7).

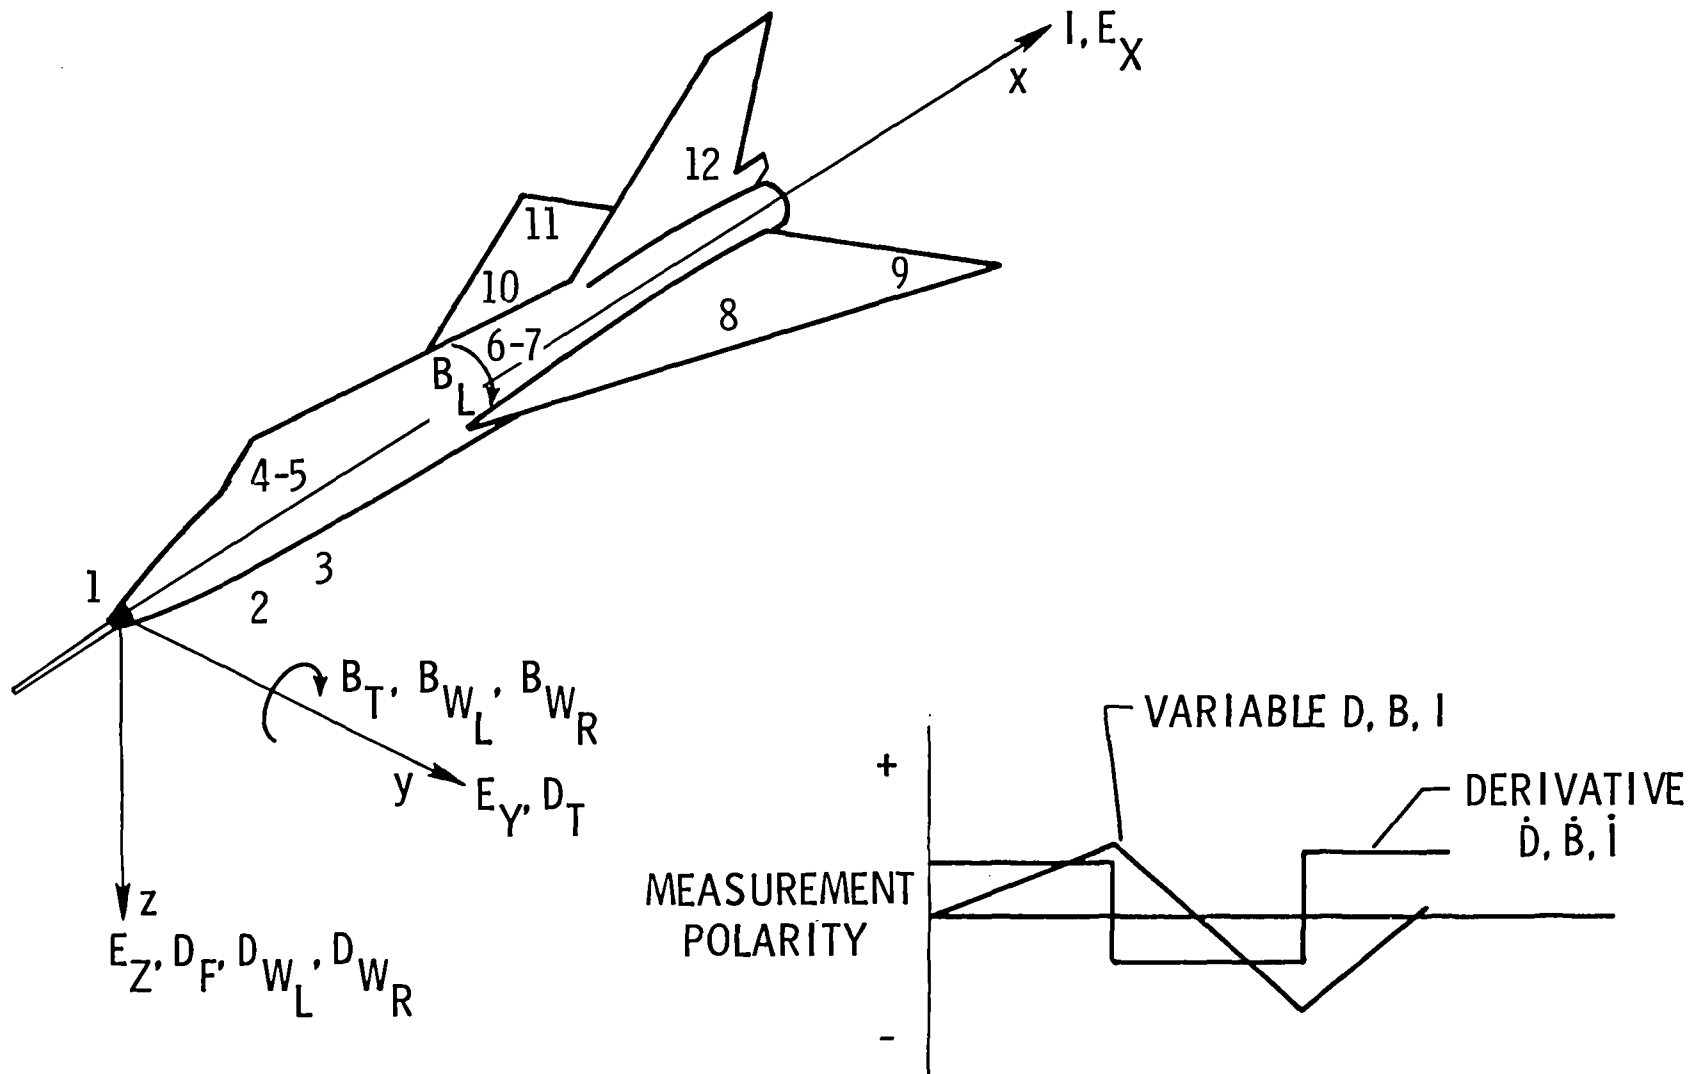
Figure 29. - Electromagnetic sign conventions and sensor locations.

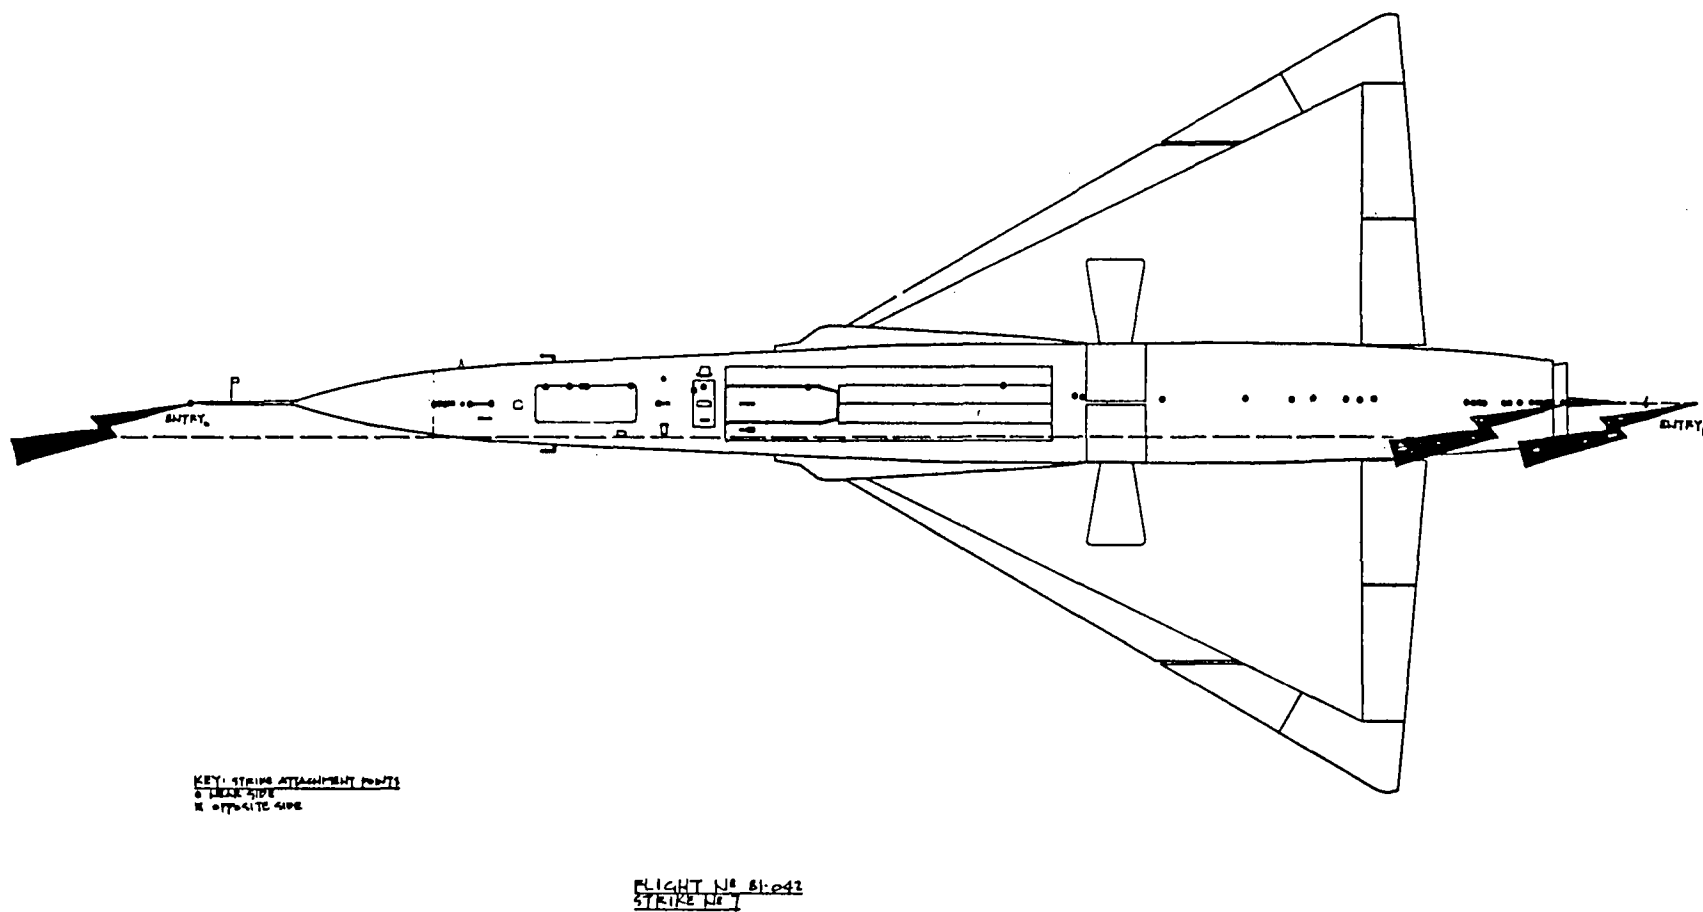
Figure 30. - Lightning attachment points - flight 81-042.

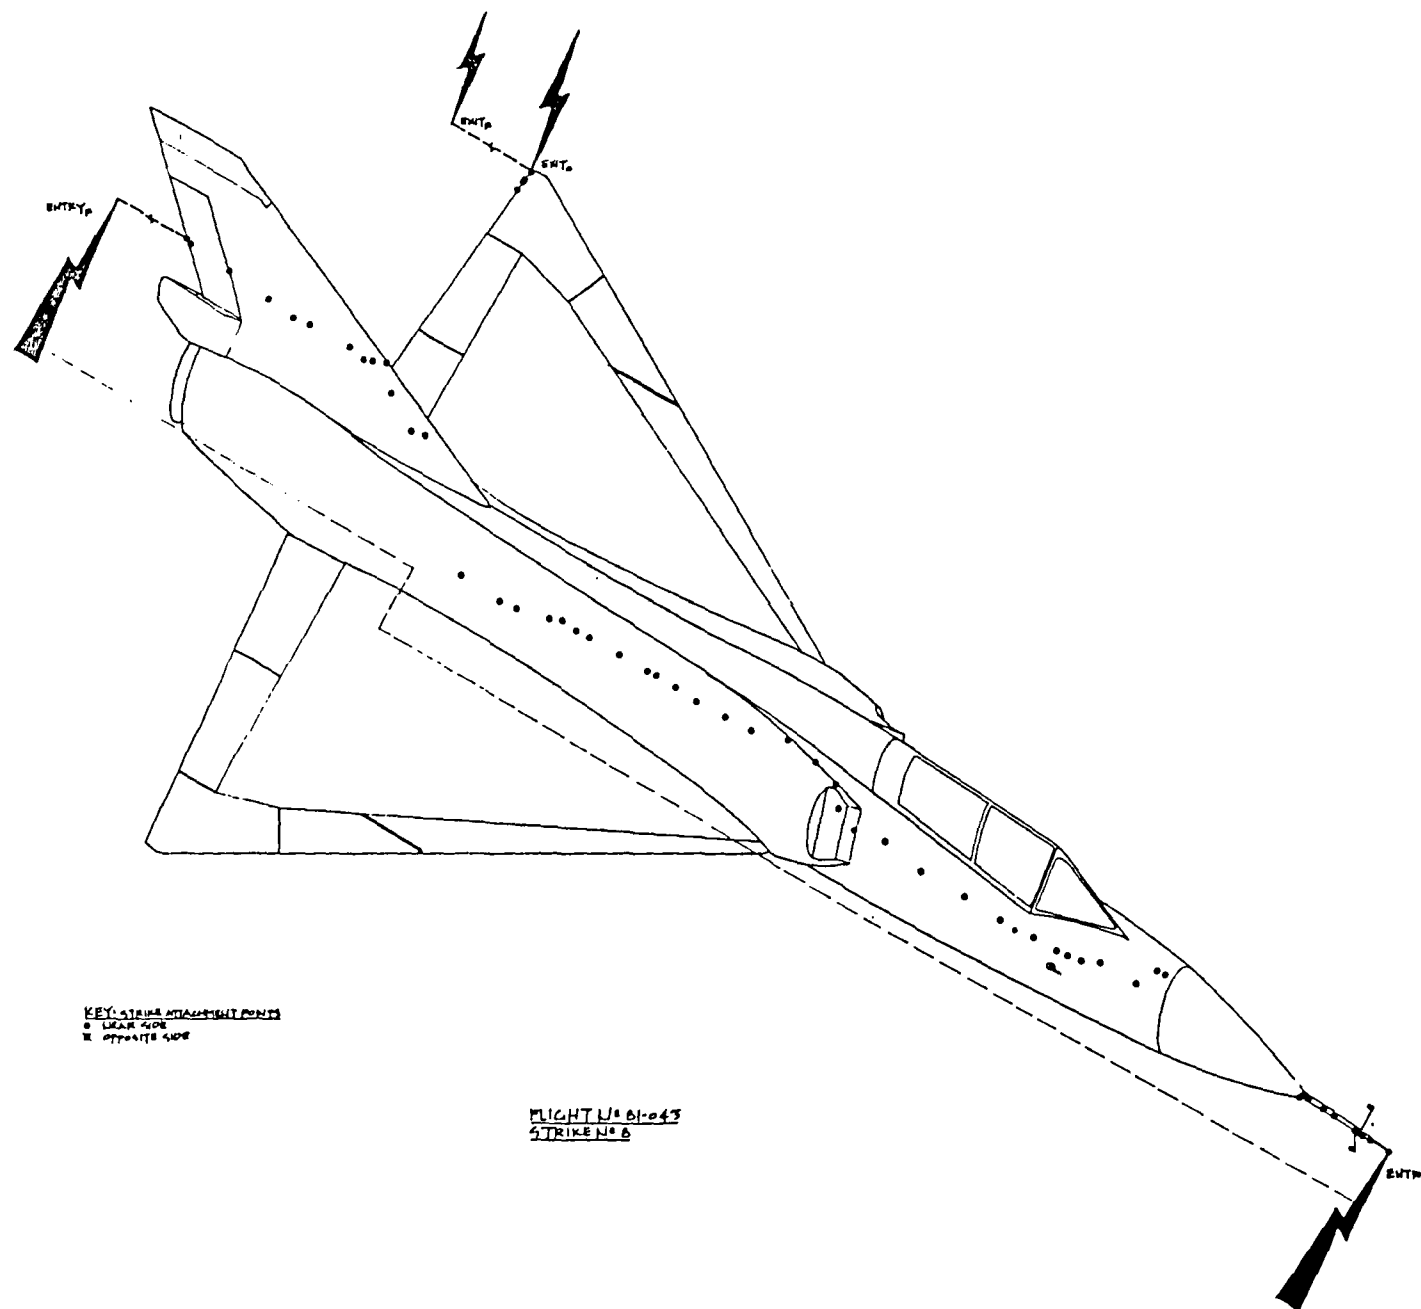
Figure 31. - Lightning attachment points - flight 81-043.

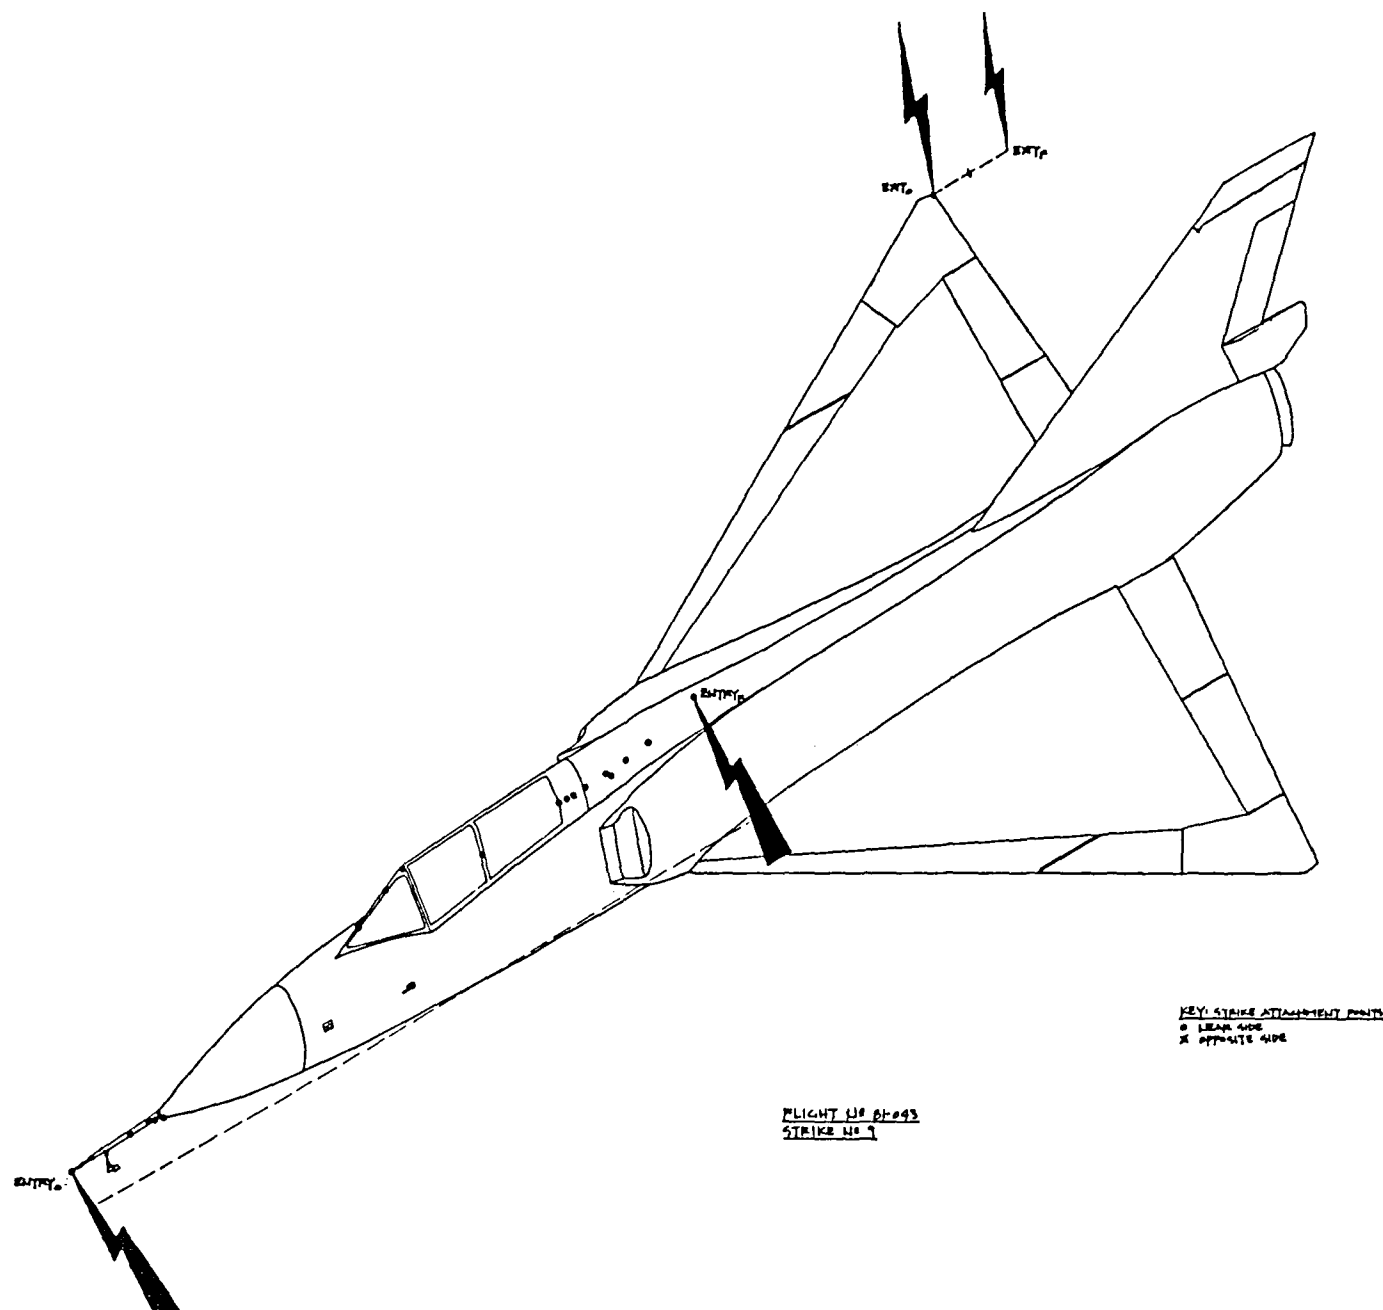
Figure 32. - Lightning attachment points - flight 81-043.

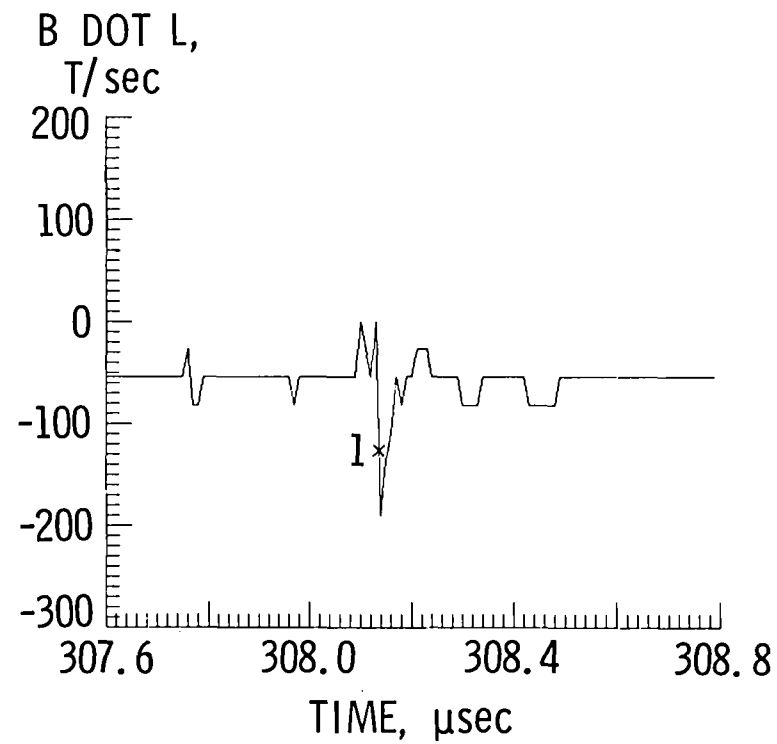
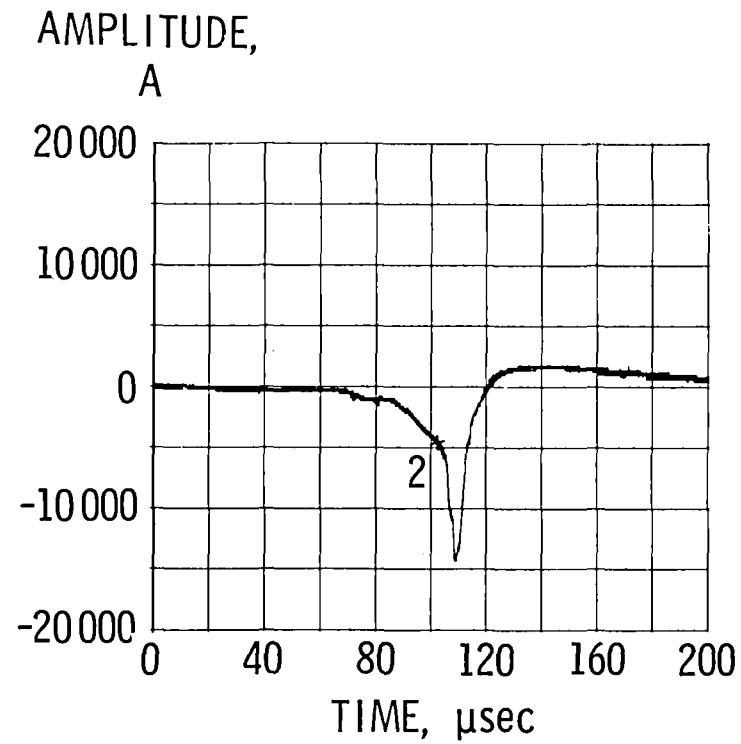
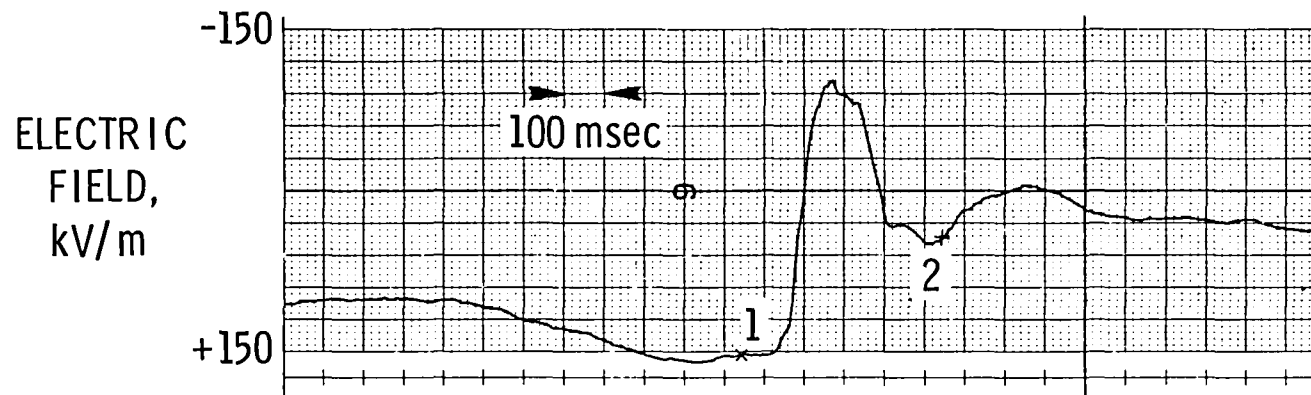
Figure 33. - Pitot boom strike waveforms.
